Manhole Inspection Summary

Manhole # S35G__033MH

Insp Date: **1/5/09 11:53 AM**

Location Address: **1 st paul st**

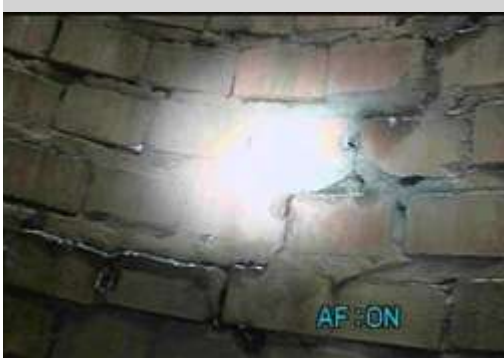
Defect 6

Condition: ☐ Sound ☒ **Cracked** ☐ Root Intrusion ☐ Loose Brick ☐ Deteriorated

corbel cracked

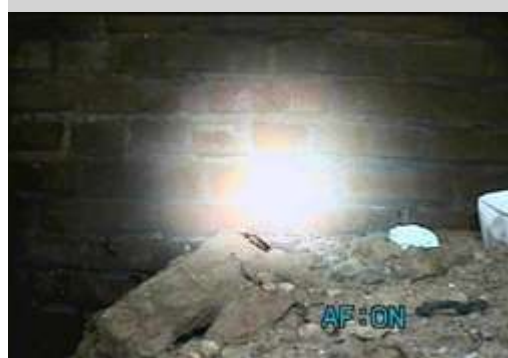
Defect 5

Condition: ☐ Sound ☐ Cracked ☐ Root Intrusion ☐ Deteriorated ☐ Leaks ☒ **Debris**

bench debris

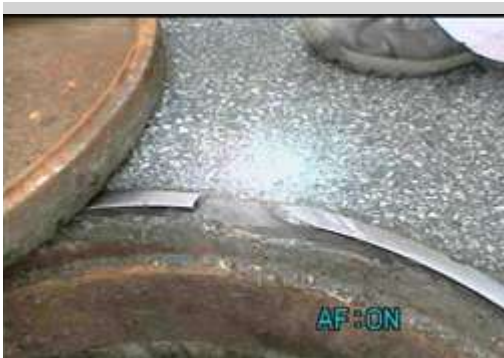
Defect 4

Condition: ☐ Sound ☒ **Cracked** ☐ Leaks

frame chipped

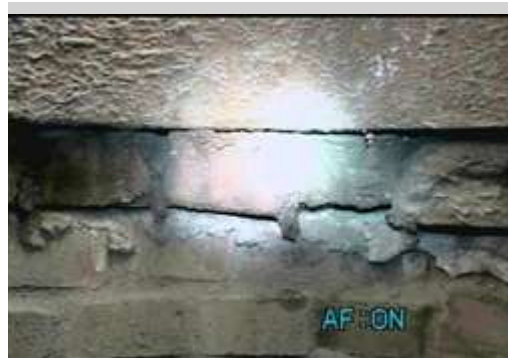
Defect 3

Condition: ☐ Sound ☐ Cracked ☐ Root Intrusion ☐ Loose Brick ☒ **Deteriorated**

chimney deteriorated at frame joint

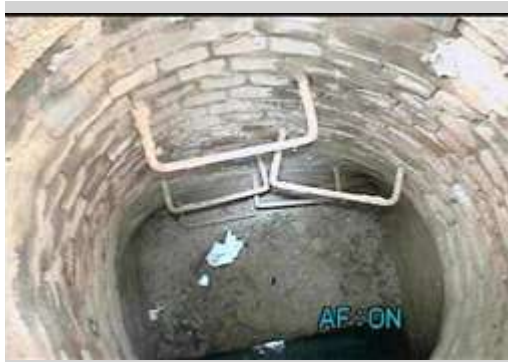
Defect 2

Count: **5** Missing: **0** ☒ **Corroded**

steps corroded

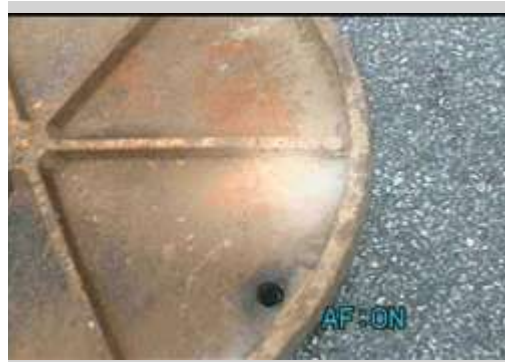
Defect 1

Condition: **Cracked**

cover cracked

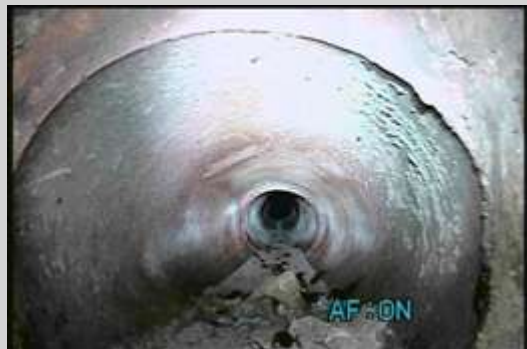
9 O'Clock Inflow

Deposits: ☐ None ☐ Mud ☐ Sludge ☒ **Debris** ☐ Grease

Silt Depth: **2.5** (in.) Deposits Extent: **Light**
